# **BEST PRACTICE AND MARINE SAFETY CRITERIA BULLETIN 01-2022**

## **BPMSCB 01-2022: Mooring Incident, Non-conformities and minimum Safety criteria for Mooring Equipment and Mooring Systems Management**

Fremantle Ports experienced a high potential mooring incident in 2021.

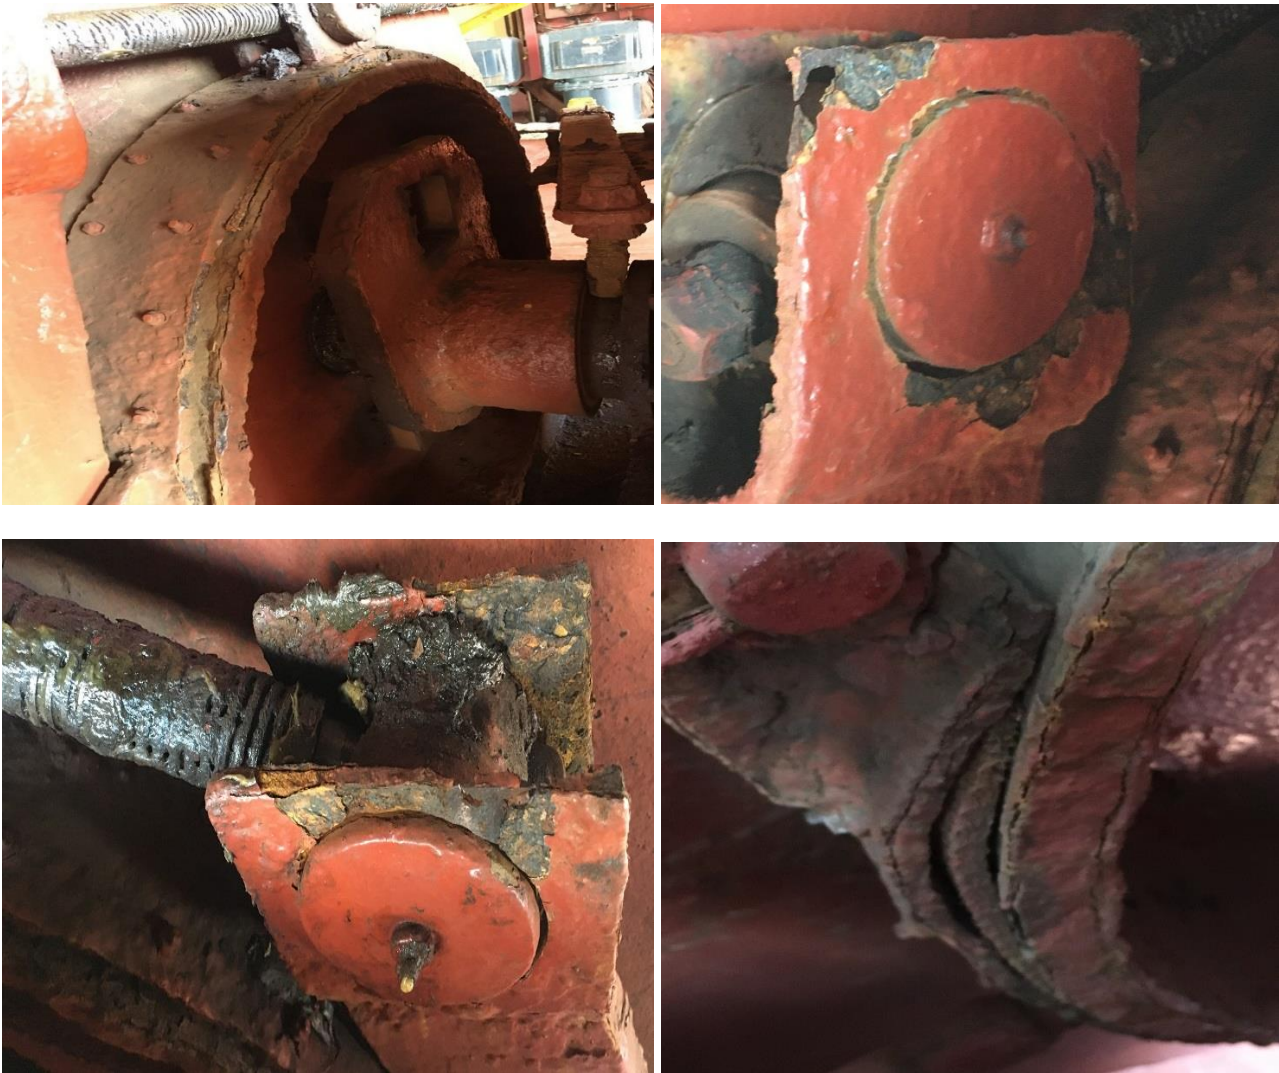
The following was noted:

- Poorly maintained mooring equipment making the vessel unacceptable to return to Fremantle
- Thinned down mooring winch brake liners incapable of safely mooring the vessel and holding the vessel alongside the berth
- Deformed and wasted winch brake drums, spindle connecting blocks, brake bands etc
- Poor condition of bollards and fairleads
- Lack of a planned monitoring regime from Shore / Ship teams to ensure continued suitability and readiness of the mooring equipment

- The vessel was deemed UNACCEPTABLE to return to the Port of Fremantle, unless rectification of the existing conditions were carried out and objective evidence provided to and verified by Fremantle Ports prior to return.
- All vessels arriving at Fremantle Ports are required to declare the condition of their mooring equipment including mooring winches, mooring ropes, ship fittings designed for towage via the Enhanced 48 Hour Notice of Arrival process.
- Pro-active initiative to board vessels for mooring condition and vessel standards inspections was initiated. Vessels are currently, randomly selected and inspected by Fremantle Ports Harbour Master's office staff to verify actual condition of mooring equipment.
